**Flood Control Project Maintenance
Levee Inspections**
LMA District Cover Sheet
Spring 2020 Levee Inspection Results

Lower San Joaquin Levee District

Spring 2020 Levee Inspection Results

Waterway			Bank	Unit Miles
Unit No. 01 San Joaquin River			Right	22.52
	Spring (March - May)	Summer (June - August)	(September - November) Fall	Winter (December - February)
Unit Maintenance Rating (Fall Only)				
Date of Inspection	4/21/2020 - 4/21/2020			
DWR Inspector	Corey Fujitani			
Accompanied By

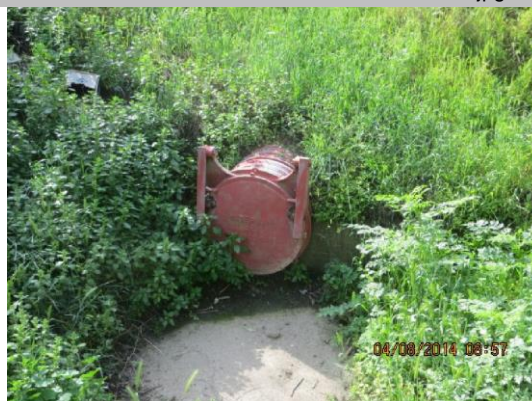
Photo 2 of 3 : UCIP_SP_2020_39091_60600.jpg

Flapgate on WS toe.

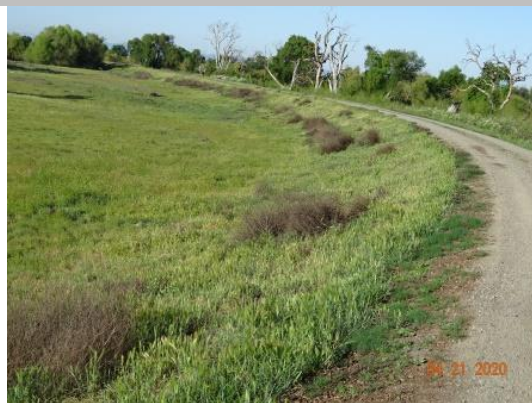
Photo 1 of 1 : SP_2020_NA0010_118_95_20200505_00286.jpg

LM Start	0.00	Rating **	M	Issue No.	95
LM End	2.53	Issue Type +	Ma	Location *	LS
Category	Earthen Levee			GPS Latitude/Longitude	
				Start	End
Item	Vegetation			37.348637 °	37.328311 °
				-120.958840 °	-120.933763 °
DWR ID	DWR_NA0010_01_s_2020_95				
Comment Code					
V1 : Control annual grass and weeds on the levee slopes and easements.					
Inspector Comment

View of the landside slope looking upstream. (Spring 2020)

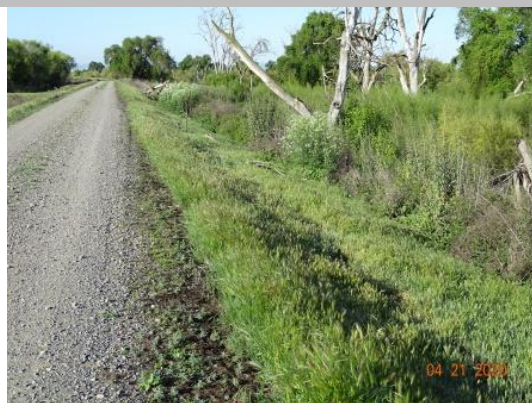
Photo 1 of 1 : SP_2020_NA0010_118_96_20200505_00287.jpg

LM Start	0.00	Rating **	M	Issue No.	96
LM End	2.55	Issue Type +	Ma	Location *	WS
Category	Earthen Levee			GPS Latitude/Longitude	
				Start	End
Item	Vegetation			37.348637 °	37.328220 °
				-120.958840 °	-120.933584 °
DWR ID	DWR_NA0010_01_s_2020_96				
Comment Code					
V1 : Control annual grass and weeds on the levee slopes and easements.					
Inspector Comment

Looking upstream along the waterside slope. (Spring 2020)

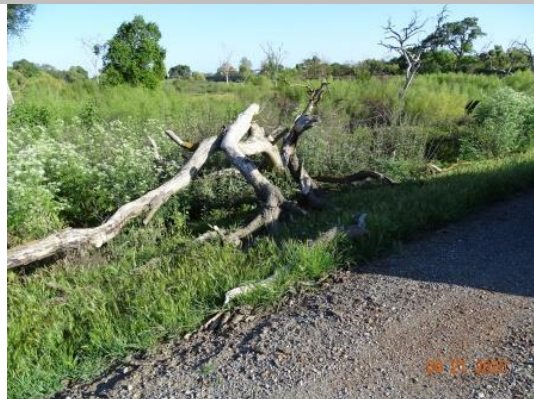
Photo 1 of 1 : SP_2020_NA0010_118_143_20200505_00288.jpg

LM Start	0.12	Rating **	M	Issue No.	143
LM End	0.12	Issue Type +	Ma	Location *	WS
Category	Earthen Levee			GPS Latitude/Longitude	
				Start	End
Item	Encroachments			37.347444 °	37.347444 °
				-120.960311 °	-120.960311 °
DWR ID	DWR_NA0010_01_s_2020_143				
Comment Code					
TR : Tree or limb					
Inspector Comment

Downed tree limb should be removed from the waterside shoulder.
(Spring 2020)

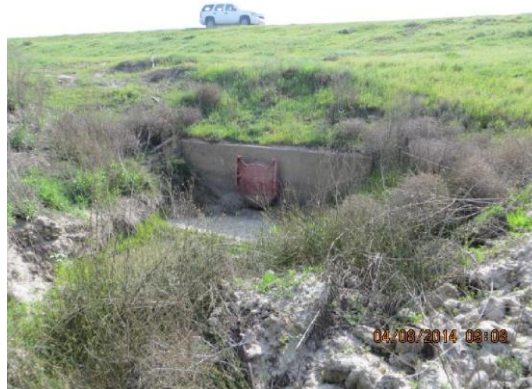
Photo 2 of 3 : UCIP_SP_2020_39092_60613.jpg

Flapgate and headwall visible off WS toe.

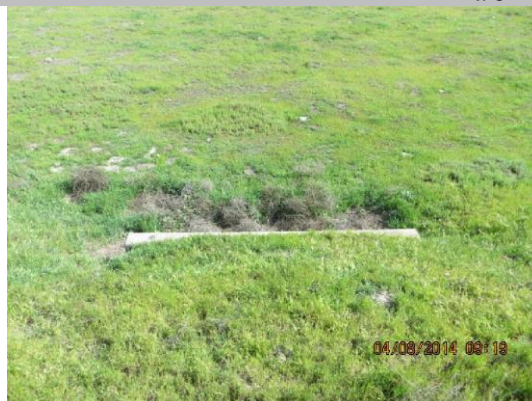
Photo 2 of 3 : UCIP_SP_2020_33524_60626.jpg

Pipe and headwall visible on LS toe.

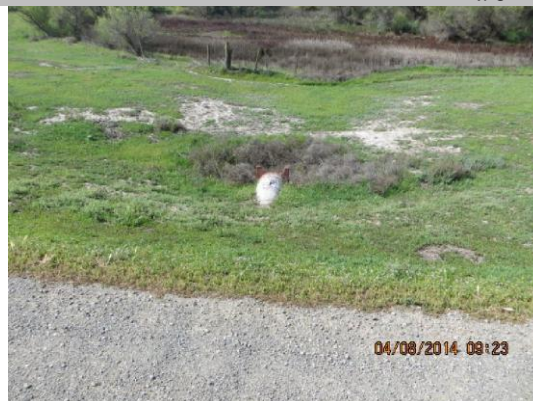
Photo 1 of 3 : UCIP_SP_2020_39096_60632.jpg

Comment Code						
Inspector Comment						
DS_ID:19585 FS_ID:39096 EP_NO: N/A Repair Type: Non-Urgent Crossing Status: Found UCIP Comments: 04/08/2014 Moderate erosion around headwall on landward toe. May or may not be an issue. Need to contact owner to determine status of crossing and to address erosion issue on landward side. (DWR UCIP - W. Wylie) FIELD_STRUCT_DESC: 24-inch corrugated metal gravity drainage pipe through the levee, 7 feet below the crown. Flap gate on the waterside (WS) end. Brass cap No. 108 bench mark (BM) on the headwall on the landside (LS). [Additional Reference(s): DWR Levee Log, 2002. USACE San Joaquin O&M Manual 601.1, 1967, (HLM 0.95)]. FS Date: 4/8/2014

Flapgate, pipe, and headwall on WS toe.

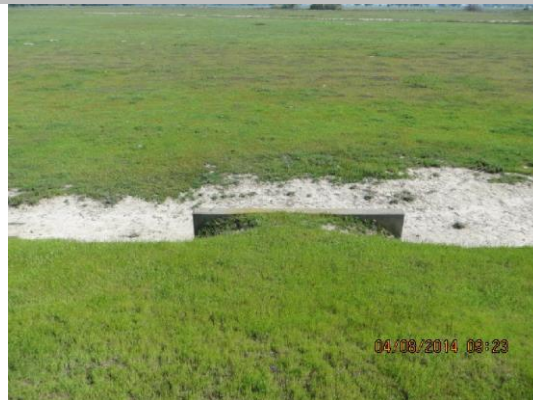
Photo 2 of 3 : UCIP_SP_2020_39096_60631.jpg

Concrete headwall and pipe visible at LS toe.

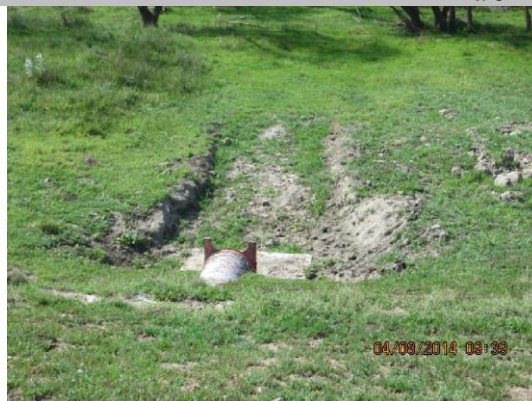
Photo 1 of 3 : UCIP_SP_2020_39099_60652.jpg

DS_ID:19588
 FS_ID:39099
 EP_NO: N/A
 Repair Type: Non-Urgent
 Crossing Status: Found
 UCIP Comments: 04/08/2014 Some sediment buildup inside pipe at LS toe. Recommend contacting owner to clear sediment buildup and check wall integrity through pipe section. (DWR UCIP - W. Wylie)
 FIELD_STRUCT_DESC: 24-inch corrugated metal gravity drainage pipe through the levee, 11 feet below the crown. Flap gate on the waterside (WS) end. Brass cap No. 108 bench mark (BM) on the headwall on the landside (LS). [Additional Reference(s): DWR Levee Log, 2002. USACE San Joaquin O&M Manual 601.1, 1967, (HLM 1.48)].
 FS Date: 4/8/2014

Pipe, flapgate, and concrete headwall visible on WS toe.

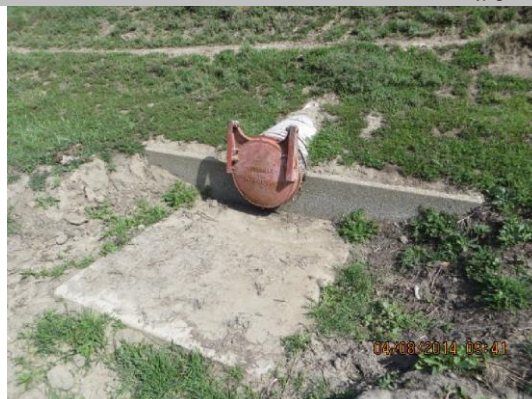
Photo 2 of 3 : UCIP_SP_2020_39099_60653.jpg

Pipe, flapgate, and concrete headwall visible on WS toe.

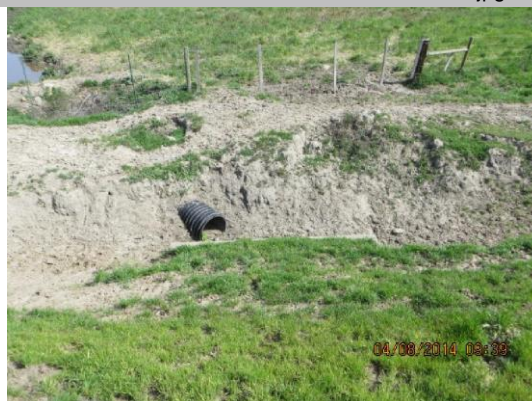
Photo 3 of 3 : UCIP_SP_2020_39099_60651.jpg

Pipe and concrete headwall visible on LS toe.

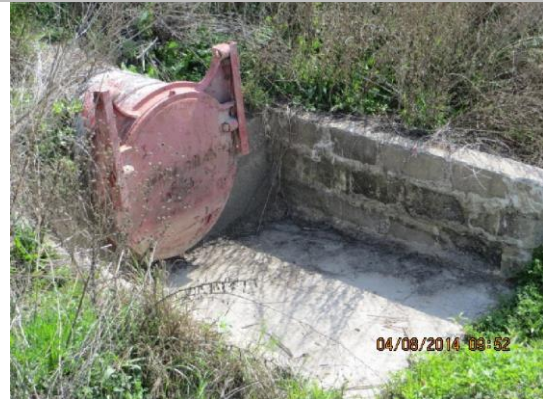
Photo 2 of 3 : UCIP_SP_2020_33564_60667.jpg

Pipe, flapgate, and headwall visible at WS toe.

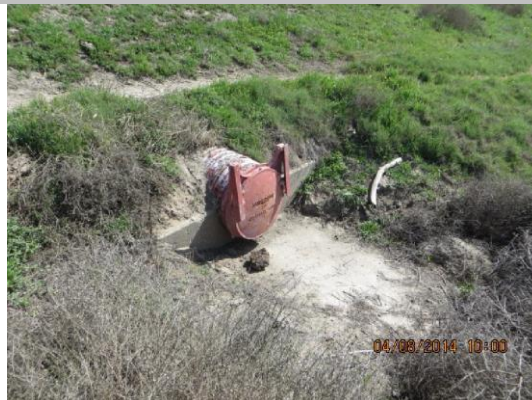
Photo 2 of 3 : UCIP_SP_2020_39100_60672.jpg

Pipe, flapgate, and headwall on WS toe.

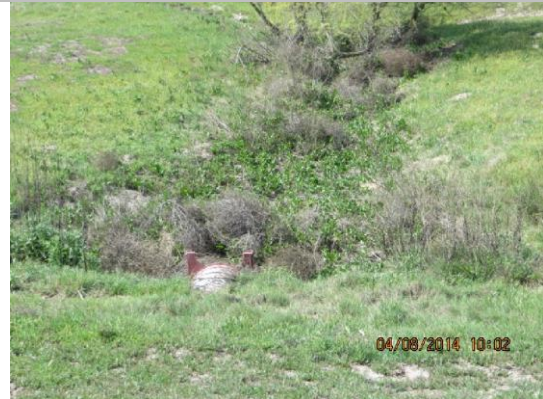
Photo 1 of 3 : UCIP_SP_2020_39123_60675.jpg

LM Start	2.06	Rating **	M	Issue No.	1196
LM End	2.06	Issue Type +	Ma	Location *	
Category	Supplemental			GPS Latitude/Longitude	
				Start	End
Item	DWR UCIP LMA Responsibility			37.333653 °	37.333653 °
				-120.938770 °	-120.938770 °
DWR ID	19570				
Comment Code					
Inspector Comment					
DS_ID:19570 FS_ID:39123 EP_NO: N/A Repair Type: Non-Urgent Crossing Status: Found UCIP Comments: 04/08/2014 Unable to find inlet on landward toe. Recommend clearing vegetation on landward side to properly inspect inlet. (DWR UCIP - W. Wylie) FIELD_STRUCT_DESC: 24-inch corrugated metal gravity drainage pipe through the levee, 9.8 feet below the crown. Flap gate on the waterside (WS) end. Brass cap No. 100 bench mark (BM) on the headwall on the landside (LS). [Additional Reference(s): DWR Levee Log, 2002. USACE San Joaquin O&M Manual 601.1, 1967, (HLM 2.08)]. FS Date: 4/8/2014

Pipe and flapgate visible on WS toe.

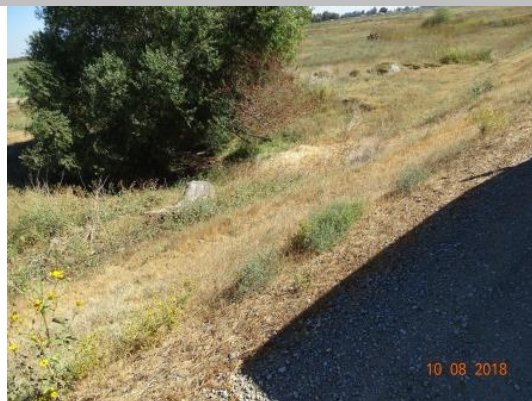
Photo 1 of 1 : SP_2020_NA0010_118_110_20200225_00021.jpg

LM Start	2.20	Rating **	N	Issue No.	110
LM End	2.20	Issue Type +	Ma	Location *	LS
Category	Earthen Levee			GPS Latitude/Longitude	
				Start	End
Item	Trim / Thin Trees			37.331820 °	37.331820 °
				-120.937605 °	-120.937605 °
DWR ID	DWR_NA0010_01_f _ 2018_110				
Comment Code					
T5 : Tree stumps.					
Inspector Comment					
Tree stump on landside slope should be removed.

View of tree stump on landside slope. (Fall 2018)

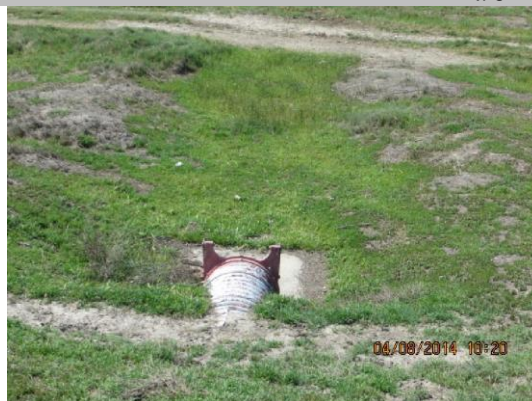
Photo 1 of 3 : UCIP_SP_2020_39127_60688.jpg

Pipe, flapgate, and headwall on WS toe.

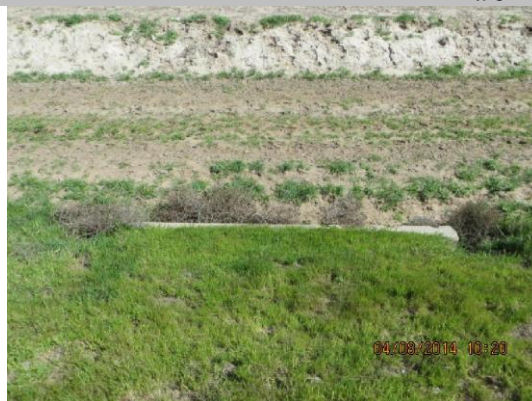
Photo 3 of 3 : UCIP_SP_2020_39127_60687.jpg

Pipe and headwall on LS toe.

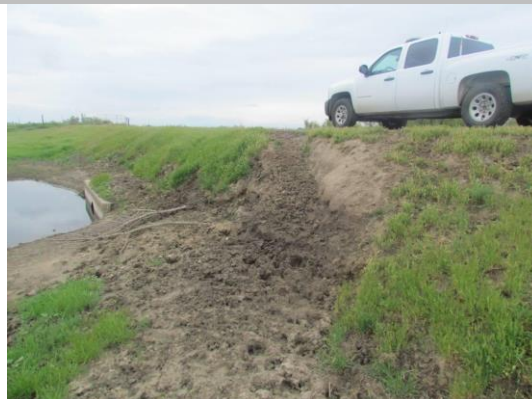
Photo 1 of 1 : SP_2020_NA0010_118_108_20200225_00019.jpg

LM Start	3.13	Rating **	M	Issue No.	108
LM End	3.13	Issue Type +	Ma	Location *	LS
Category	Earthen Levee			GPS Latitude/Longitude	
				Start	End
Item	Animal Control			37.321488 °	37.321488 °
				-120.928758 °	-120.928758 °
DWR ID	DWR_NA0010_01_s_2017_108				
Comment Code					
A2 : Repair the levee slope damaged by livestock and prevent large animal access.					
Inspector Comment					
Slope damage caused by animal traffic on landside toe.

Looking west at slope damage caused by animal traffic.

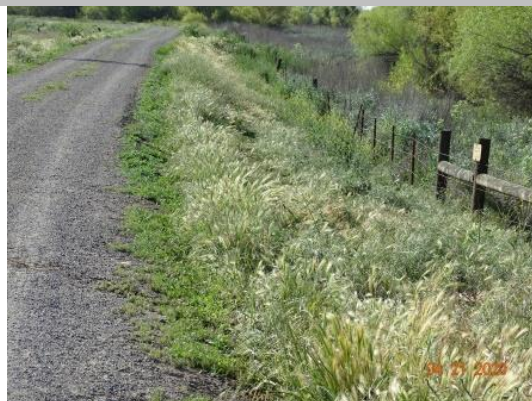
Photo 1 of 1 : SP_2020_NA0010_118_144_20200506_00294.jpg

LM Start	3.16	Rating **	U	Issue No.	144
LM End	10.69	Issue Type +	Ma	Location *	WS
Category	Earthen Levee			GPS Latitude/Longitude	
				Start	End
Item	Vegetation			37.321071 °	37.283679 °
				-120.928799 °	-120.833221 °
DWR ID	DWR_NA0010_01_s_2020_144				
Comment Code					
V1 : Control annual grass and weeds on the levee slopes and easements.					
Inspector Comment

View of vegetation on the waterside slope. (Spring 2020)

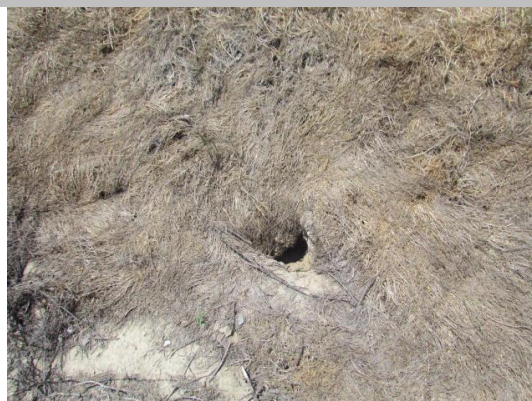
Photo 1 of 1 : SP_2020_NA0010_118_10_20200225_00008.jpg

LM Start	3.16	Rating **	M	Issue No.	10
LM End	3.16	Issue Type +	Ma	Location *	LS
Category	Earthen Levee			GPS Latitude/Longitude	
				Start	End
Item	Animal Control			37.321053 °	37.321053 °
				-120.928785 °	-120.928785 °
DWR ID	DWR_NA0010_01_s_2012_10				
Comment Code					
A3 : No rodents visible, but rodent burrows visible; need to backfill and compact or grout burrows.					
Inspector Comment					
Several rodent holes noted within this section. Rodent hole noted on landside shoulder next to fence pole.

Looking at typical view of rodent holes on landward slope.

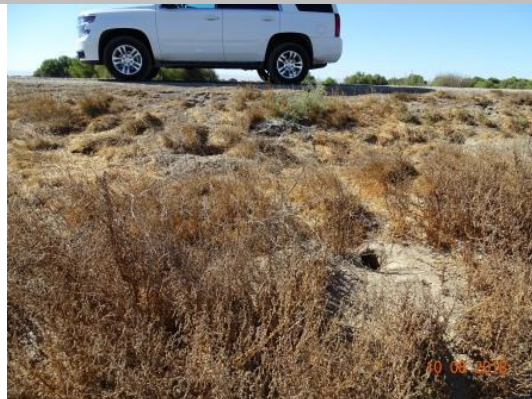
Photo 1 of 1 : SP_2020_NA0010_118_116_20200225_00028.jpg

LM Start	3.18	Rating **	M	Issue No.	116
LM End	3.18	Issue Type +	Ma	Location *	LS
Category	Earthen Levee			GPS Latitude/Longitude	
				Start	End
Item	Animal Control			37.320725 °	37.320725 °
				-120.928837 °	-120.928837 °
DWR ID	DWR_NA0010_01_f_2018_116				
Comment Code					
A3 : No rodents visible, but rodent burrows visible; need to backfill and compact or grout burrows.					
Inspector Comment					
Several rodent holes noted in this section.

View of landside slope with rodent holes. (Fall 2018)

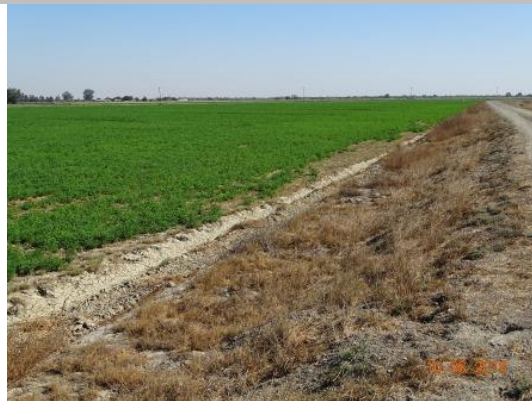
Photo 1 of 1 : SP_2020_NA0010_118_117_20200225_00030.jpg

LM Start	3.23	Rating **	M	Issue No.	117
LM End	3.90	Issue Type +	En	Location *	LS
Category	Earthen Levee			GPS Latitude/Longitude	
				Start	End
Item	Encroachments			37.320029 °	37.311311 °
				-120.928556 °	-120.927310 °
DWR ID	DWR_NA0010_01_f_2018_117				
Comment Code					
DT : Ditch					
Inspector Comment					
Earthen ditch along landside toe.

Earthen ditch along landside toe. (Fall 2018)

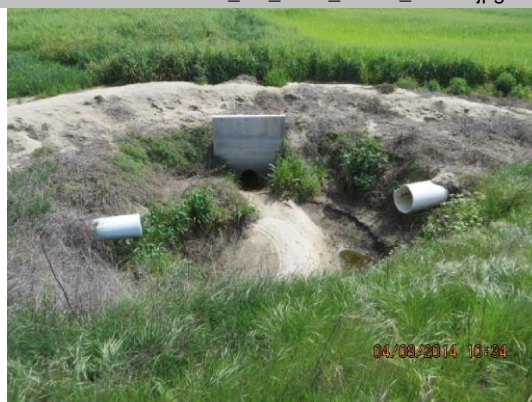
Photo 2 of 3 : UCIP_SP_2020_53188_60706.jpg

Pipe and headwall on LS toe.

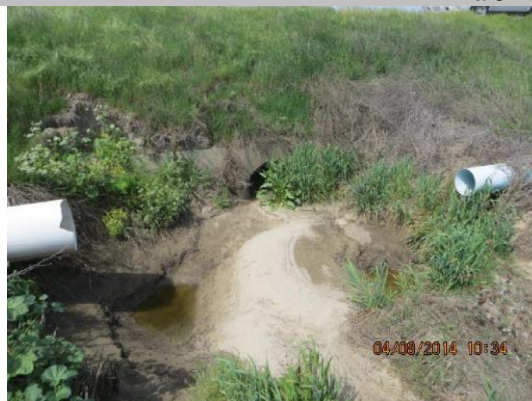
Photo 3 of 3 : UCIP_SP_2020_53188_60705.jpg

Pipe and headwall on LS toe.

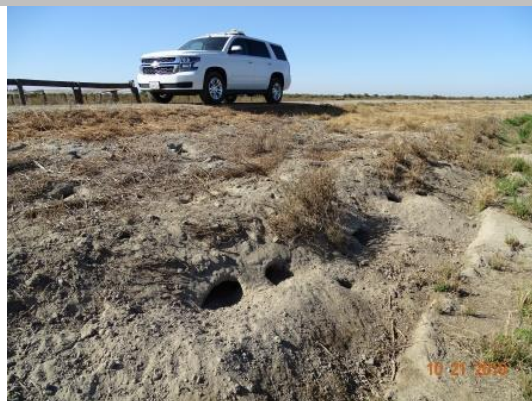
Photo 1 of 1 : SP_2020_NA0010_118_2_20200225_00001.jpg

LM Start	3.87	Rating **	U	Issue No.	2
LM End	3.90	Issue Type +	Ma	Location *	LS
Category	Earthen Levee			GPS Latitude/Longitude	
				Start	End
Item	Animal Control			37.311798 °	37.311341 °
				-120.927670 °	-120.927365 °
DWR ID	DWR_NA0010_01_s_2012_2				
Comment Code					
A1 : Exterminate rodents and backfill and compact or grout burrows.					
Inspector Comment					
Several rodent burrows are along this section of the levee.

View of rodent burrows in this section looking downstream. (Fall 2019)

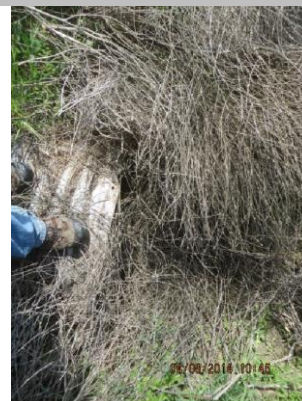
DS_ID:19576
FS_ID:39132
EP_NO: N/A
Repair Type: Non-Urgent
Crossing Status: Found
UCIP Comments: 04/08/2014 Slide gate missing from WS. No closure device, but degrading of levee at Highway 140 is lower than pipe, so this does not appear to be a critical issue. Also dense vegetation limits the inspector's visibility to identify signs of pipe failure (leaks) along the slope. Recommend removing vegetation along pipe alignment to conduct proper inspection of structure and appurtenances. (DWR UCIP - W. Wylie)
FIELD_STRUCT_DESC: 30-inch corrugated metal gravity drainage pipe through the levee, 3.5 feet below the crown. Flap gate on the waterside (WS) end. Brass cap No. 100 bench mark (BM) on the headwall on the landside (LS). [Additional Reference(s): DWR Levee Log, 2002. USACE San Joaquin O&M Manual 601.1, 1967, (HLM 3.95)].
FS Date: 4/8/2014

Slide gate missing on WS toe with heavy vegetation camouflaging pipe

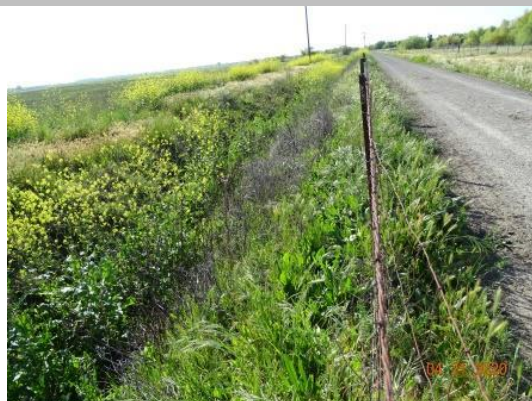
Photo 1 of 1 : SP_2020_NA0010_118_5_20200506_00295.jpg

LM Start	3.98	Rating **	U	Issue No.	5
LM End	4.05	Issue Type +	En	Location *	LS
Category	Earthen Levee			GPS Latitude/Longitude	
				Start	End
Item	Encroachments			37.310837 °	37.310003 °
				-120.926182 °	-120.925313 °
DWR ID	DWR_NA0010_01_s_2012_5				
Comment Code					
DT : Ditch					
Inspector Comment					
Irrigation ditch at landside toe.

Looking south at irrigation ditch at the landside toe. (Spring 2020)

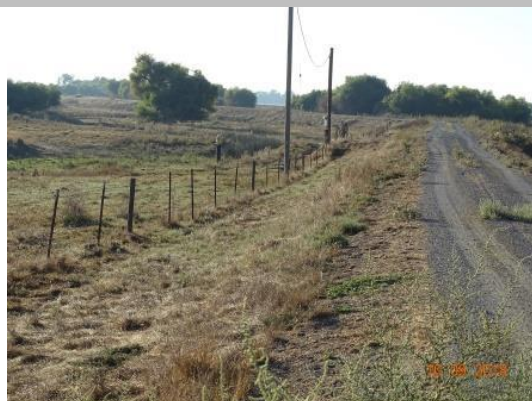
Photo 1 of 1 : SP_2020_NA0010_118_118_20200225_00031.jpg

LM Start	3.99	Rating **	M	Issue No.	118
LM End	4.25	Issue Type +	En	Location *	LS
Category	Earthen Levee			GPS Latitude/Longitude	
				Start	End
Item	Encroachments			37.310693 °	37.307895 °
				-120.926024 °	-120.922935 °
DWR ID	DWR_NA0010_01_f_2018_118				
Comment Code					
FE : Fence					
Inspector Comment					
Fence along landside toe.

View of fence along landside toe. (Fall 2018)

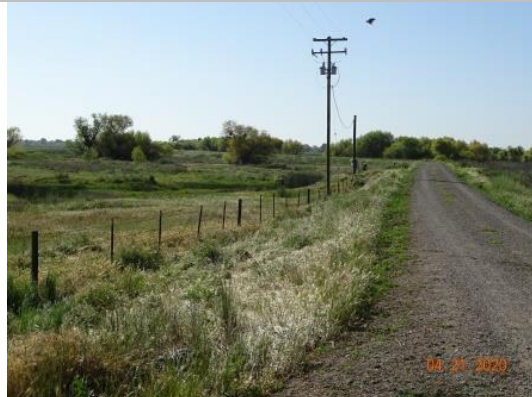
Photo 1 of 1 : SP_2020_NA0010_118_146_20200506_00296.jpg

LM Start	4.08	Rating **	U	Issue No.	146
LM End	10.69	Issue Type +	Ma	Location *	LS
Category	Earthen Levee			GPS Latitude/Longitude	
				Start	End
Item	Vegetation			37.309734 °	37.283679 °
				-120.924982 °	-120.833221 °
DWR ID	DWR_NA0010_01_s_2020_146				
Comment Code					
V1 : Control annual grass and weeds on the levee slopes and easements.					
Inspector Comment

Vegetation growing along the landside slope. (Spring 2020)

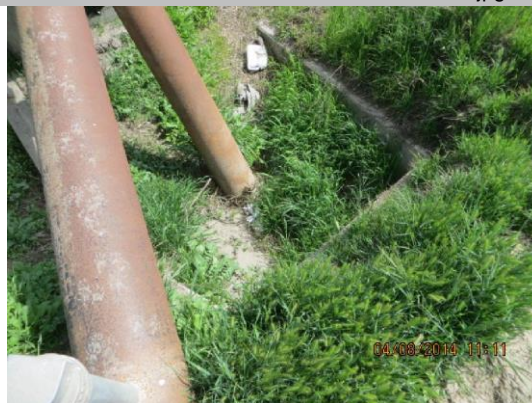
Photo 2 of 2 : UCIP_SP_2020_39138_71319.jpg

Pipe through existing 48 inch pipe.

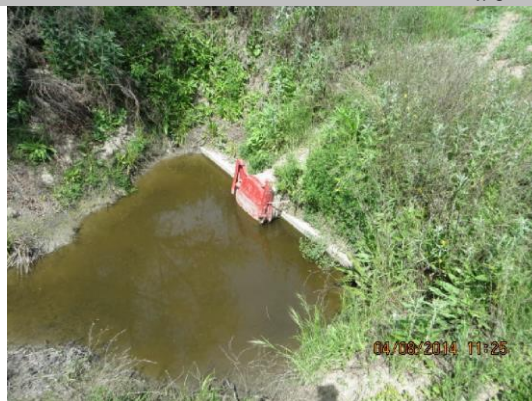
Photo 2 of 3 : UCIP_SP_2020_39140_60732.jpg

Pipe, flapgate, and headwall visible at WS toe.

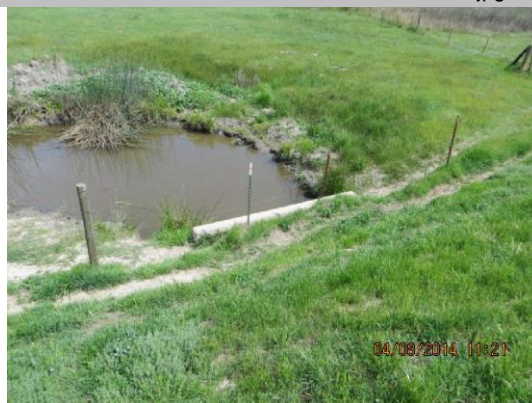
Photo 3 of 3 : UCIP_SP_2020_39140_60734.jpg

Concrete headwall at LS toe.

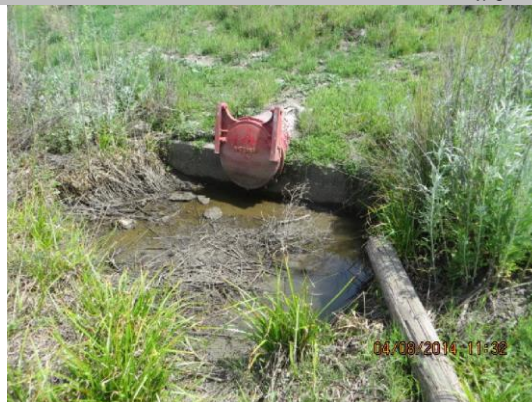
Photo 2 of 3 : UCIP_SP_2020_39141_60738.jpg

Pipe, flapgate, and headwall on WS toe.

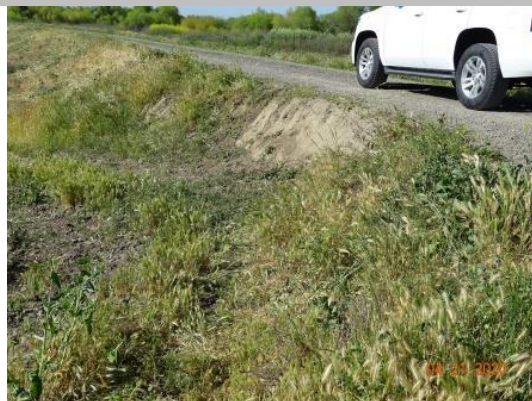
Photo 1 of 1 : SP_2020_NA0010_118_9_20200506_00297.jpg

LM Start	4.69	Rating **	U	Issue No.	9
LM End	4.69	Issue Type +	Ma	Location *	LS
Category	Earthen Levee			GPS Latitude/Longitude	
				Start	End
Item	Animal Control			37.302398 °	37.302398 °
				-120.920920 °	-120.920920 °
DWR ID	DWR_NA0010_01_s_2013_9				
Comment Code					
A2 : Repair the levee slope damaged by livestock and prevent large animal access.					
Inspector Comment					
Levee landside toe damaged by livestock.

View of damage to the landside slope. (Spring 2020)

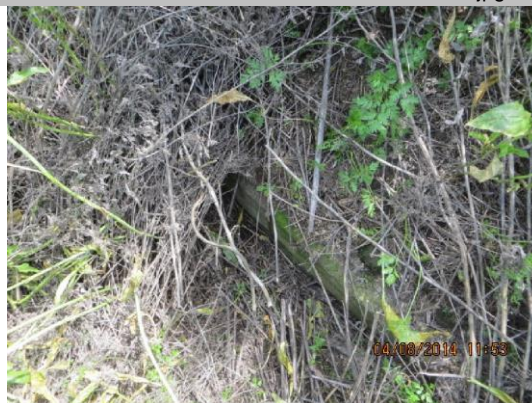
Photo 2 of 2 : UCIP_SP_2020_39151_60741.jpg

Top of concrete headwall just visible on LS toe.

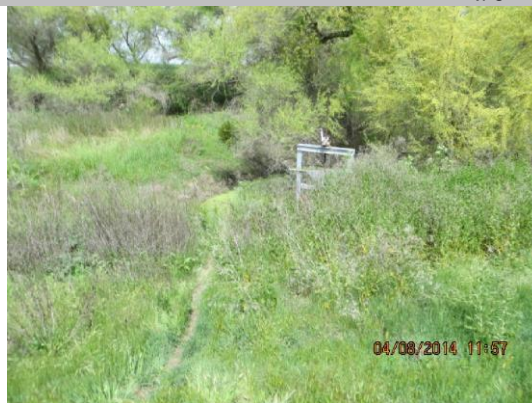
Photo 1 of 3 : UCIP_SP_2020_39152_60745.jpg

Comment Code						
Inspector Comment						
DS_ID:19612 FS_ID:39152 EP_NO: N/A Repair Type: Non-Urgent Crossing Status: Found UCIP Comments: 04/08/2014 Dense vegetation limits the inspector's visibility to identify signs of pipe failure (leaks) along waterward and landward slopes. Recommend removing vegetation along pipe alignment to conduct proper inspection of structure and appurtenances. Pipe completely blocked by soil on LS toe due to animal activity. Slide gate blocked open. (DWR UCIP - W. Wylie) FIELD_STRUCT_DESC: 48-inch corrugated metal gravity drainage pipe through the levee, 13.1 feet below the crown. Walkway to slide gate at the concrete headwall on the landside (LS) toe. Flap gate at the concrete headwall on the waterside (WS) toe. Brass cap No. 90 bench mark (BM) on the headwall on the LS. Pipe crosses the levee at an angle. [Additional Reference(s): DWR Levee Log, 2002. USACE San Joaquin O&M Manual 601.1, 1967, (HLM 6.13)]. FS Date: 4/8/2014

Slidegate at LS toe.

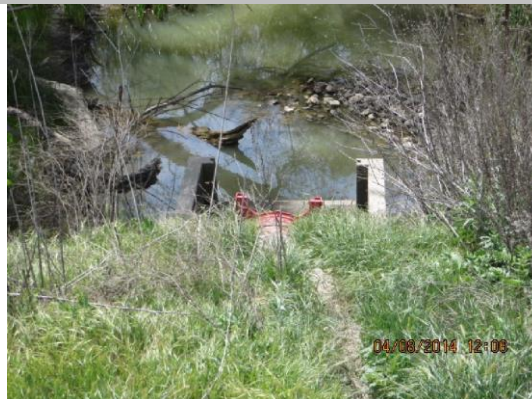
Photo 1 of 3 : UCIP_SP_2020_39154_60762.jpg

DS_ID:19613
 FS_ID:39154
 EP_NO: N/A
 Repair Type: Non-Urgent
 Crossing Status: Found
 UCIP Comments: 04/08/2014 Dense vegetation limits the inspector's visibility to identify signs of pipe failure (leaks) along the slope. Recommend removing vegetation along pipe alignment to conduct proper inspection of structure and appurtenances. (DWR UCIP - W. Wylie)
 FIELD_STRUCT_DESC: 24-inch corrugated metal gravity drainage pipe through the levee, 9.5 feet below the crown. Flap gate on the waterside (WS) end. Slide gate on the landside (LS) end next to a 48-inch concrete riser with walkway over the top. Brass cap No. 90 bench mark (BM) on the headwall on the LS. [Additional Reference(s): DWR Levee Log, 2002. USACE San Joaquin O&M Manual 601.1, 1967, (HLM 6.40)].
 FS Date: 4/8/2014

Pipe, flapgate, and concrete headwall on WS toe.

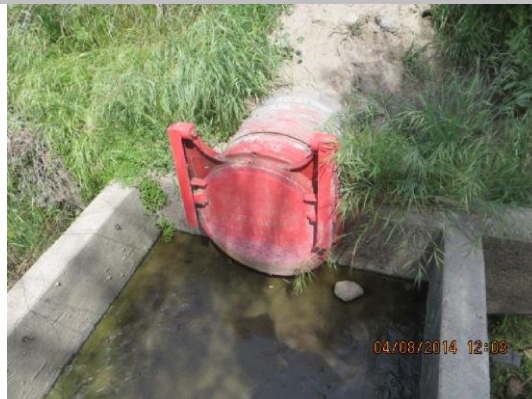
Photo 2 of 3 : UCIP_SP_2020_39154_60760.jpg

Pipe, flapgate, and concrete headwall on WS toe.

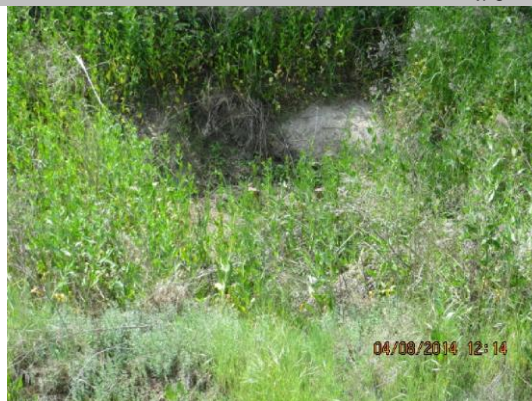
Photo 1 of 3 : UCIP_SP_2020_49962_60764.jpg

DS_ID:19614
FS_ID:49962
EP_NO: N/A
Repair Type: Non-Urgent
Crossing Status: Found
UCIP Comments: 7/19/2016 Same as previous inspection. Outlet and inlet are under water. (DWR UCIP - O. Magana)4/08/2014 Flapgate blocked by sedimentation at WS toe. Dense vegetation limits the inspector's visibility to identify signs of pipe failure (leaks) along the slope. Recommend removing vegetation along pipe alignment to conduct proper inspection of structure and appurtenances. Also recommend clearing vegetation from both waterward and landward toe. (DWR UCIP - W. Wylie)
FIELD_STRUCT_DESC: 24-inch corrugated metal gravity drainage pipe through the levee, 9.8 feet below the crown. Wooden fence around a 4-foot by 4-foot drop inlet on the landside (LS) toe. Flap gate on the waterside (WS) end. Brass cap No. 90 bench mark (BM) on the headwall on the LS. [Additional Reference(s): DWR Levee Log, 2002. USACE San Joaquin O&M Manual 601.1, 1967, (HLM 6.64)].

Pipe and flapgate visible on WS toe.

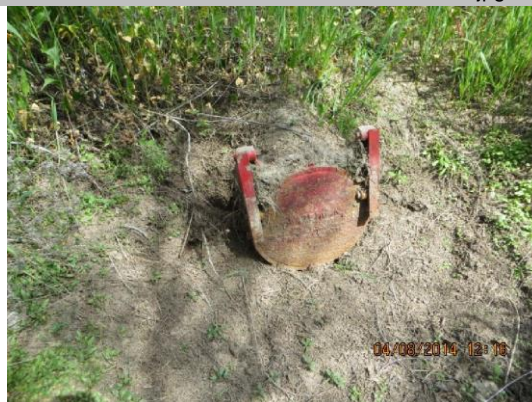
Photo 2 of 3 : UCIP_SP_2020_49962_60766.jpg

Pipe and flapgate visible at WS toe. Flapgate blocked by sedimentation on WS toe.

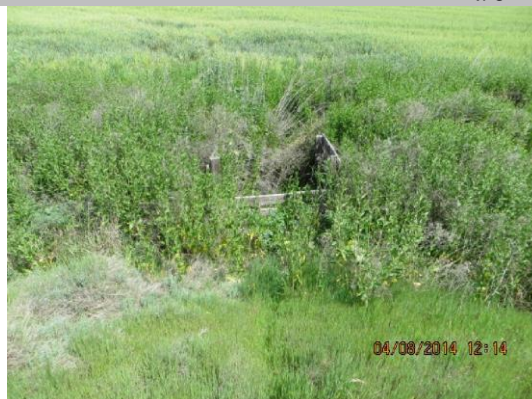
Photo 3 of 3 : UCIP_SP_2020_49962_60765.jpg

Wooden barrier around drop inlet on LS toe. Excess vegetation.

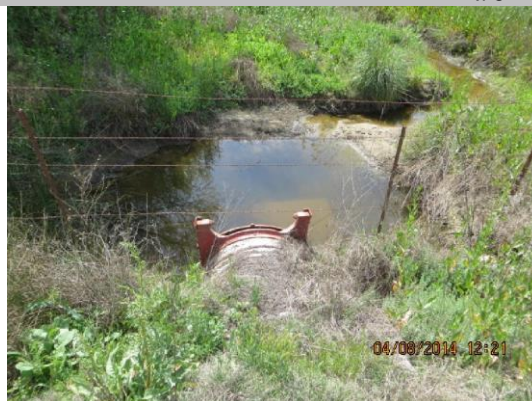
Photo 1 of 3 : UCIP_SP_2020_50077_60768.jpg

DS_ID:19615
 FS_ID:50077
 EP_NO: N/A
 Repair Type: Non-Urgent
 Crossing Status: Found
 UCIP Comments: 7/19/2016 Potential LS slope damage--difficult to determine due to dense vegetation. Limited access on WS toe due to wire fence. (DWR UCIP - O. Magana)4/08/2014 Slide gate blocked by debris at LS toe. Flapgate won't close because of debris. Dense vegetation limits the inspector's visibility to identify signs of pipe failure (leaks) along the slope. Recommend removing vegetation along pipe alignment to conduct proper inspection of structure and appurtenances. (DWR UCIP - W. Wylie)
 FIELD_STRUCT_DESC: 36-inch corrugated metal gravity drainage pipe through the levee, 10.3 feet below the crown. Slide gate on the landside (LS) toe. Flap gate on the waterside (WS) end. Brass cap No. 90 bench mark (BM) on the headwall on the LS. [Additional Reference(s): DWR Levee Log, 2002. USACE San Joaquin O&M Manual 601.1, 1967, (HLM 6.90)].

Pipe, headwall, and flapgate on WS toe.

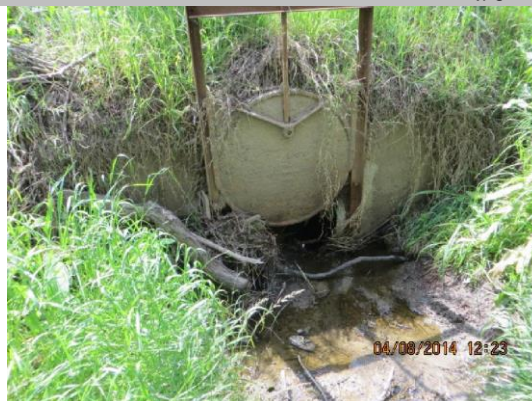
Photo 2 of 3 : UCIP_SP_2020_50077_60767.jpg

Pipe, concrete headwall, and slidegate on LS toe. Debris blocking closure of slidegate.

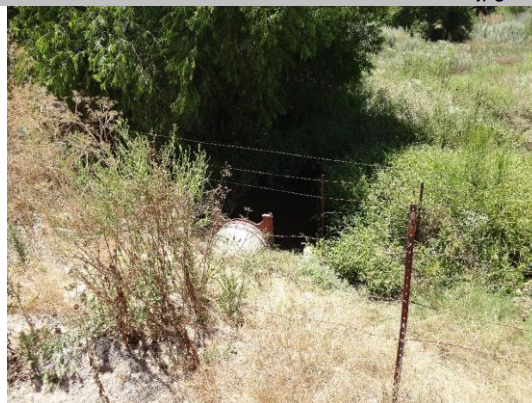
Photo 3 of 3 : UCIP_SP_2020_50077_75470.jpg

View of WS--fence limits access to flap gate.

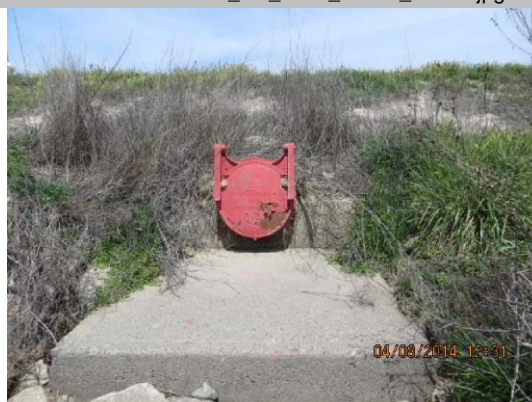
Photo 2 of 3 : UCIP_SP_2020_53412_60772.jpg

Flapgate and concrete headwall on WS toe.

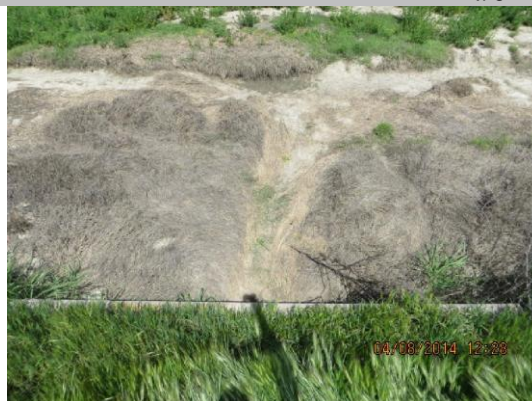
Photo 3 of 3 : UCIP_SP_2020_53412_60771.jpg

Pipe and Concrete headwall visible on LS toe.

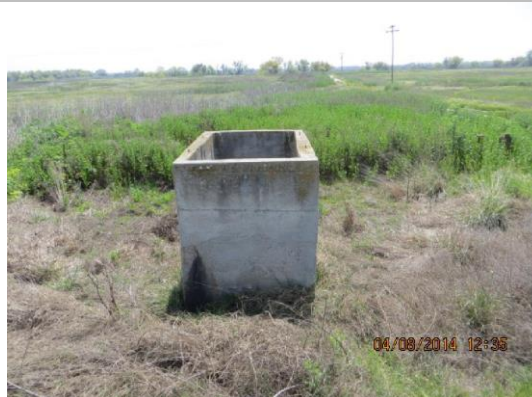
Photo 2 of 3 : UCIP_SP_2020_39160_60775.jpg

5'X7' concrete box riser on WS toe.

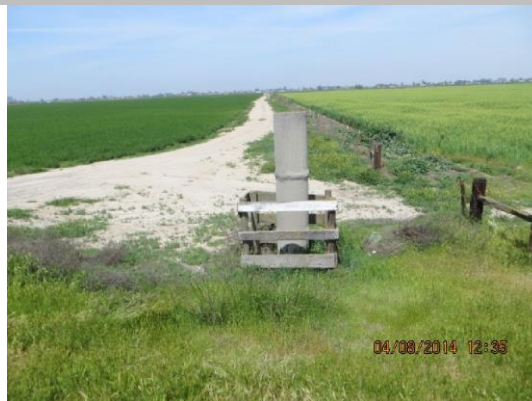
Photo 3 of 3 : UCIP_SP_2020_39160_60774.jpg

20-inch concrete standpipe off LS toe.

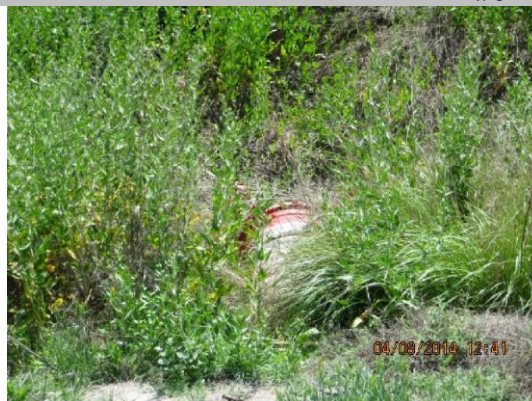
Photo 1 of 3 : UCIP_SP_2020_39161_60778.jpg

Comment Code						
Inspector Comment						
DS_ID:19618 FS_ID:39161 EP_NO: N/A Repair Type: Non-Urgent Crossing Status: Found UCIP Comments: 04/08/2014 Dense vegetation limits the inspector's visibility to identify signs of pipe failure (leaks) along the slope. Recommend removing vegetation along pipe alignment to conduct proper inspection of structure and appurtenances. (DWR UCIP - W. Wylie) FIELD_STRUCT_DESC: 24-inch corrugated metal gravity drainage pipe through the levee, 8 feet below the crown. Flap gate on the waterside (WS) end. Brass cap No. 80 bench mark (BM) on the headwall on the landside (LS). [Additional Reference(s): DWR Levee Log, 2002. USACE San Joaquin O&M Manual 601.1, 1967, (HLM 7.46)]. FS Date: 4/8/2014

Pipe and flapgate visible on WS toe.

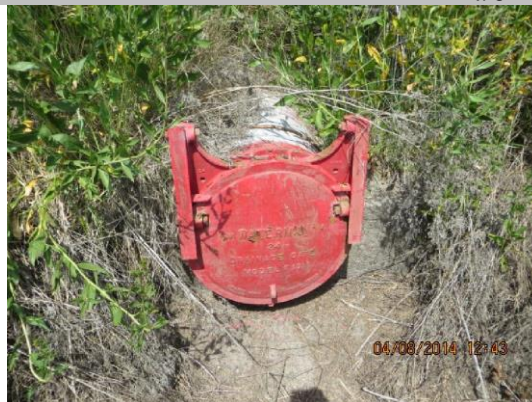
Photo 2 of 3 : UCIP_SP_2020_39161_60780.jpg

Pipe and flapgate visible on WS toe.

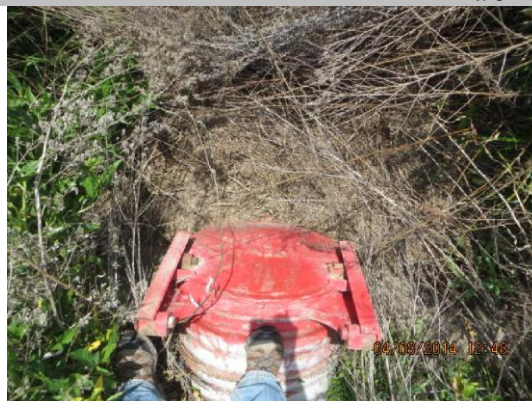
Photo 2 of 3 : UCIP_SP_2020_39243_60840.jpg

Flapgate and headwall at WS toe.

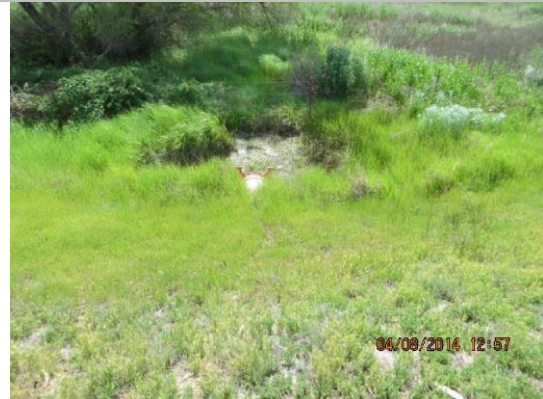
Photo 1 of 3 : UCIP_SP_2020_39244_60844.jpg

Comment Code						
Inspector Comment						
DS_ID:19620 FS_ID:39244 EP_NO: N/A Repair Type: Non-Urgent Crossing Status: Found UCIP Comments: 04/09/2014 Dense vegetation limits the inspector's visibility to identify signs of pipe failure (leaks) along the slope. Recommend removing vegetation along pipe alignment to conduct proper inspection of structure. (DWR UCIP - W. Wylie) FIELD_STRUCT_DESC: 24-inch corrugated metal gravity drainage pipe through the levee, 8 feet below the crown. Flap gate on the waterside (WS) end. Brass cap No. 80 bench mark (BM) on the headwall on the landside (LS). [Additional Reference(s): DWR Levee Log, 2002. USACE San Joaquin O&M Manual 601.1, 1967, (HLM 8.07)]. FS Date: 4/9/2014

Pipe, Headwall, and flapgate at WS toe.

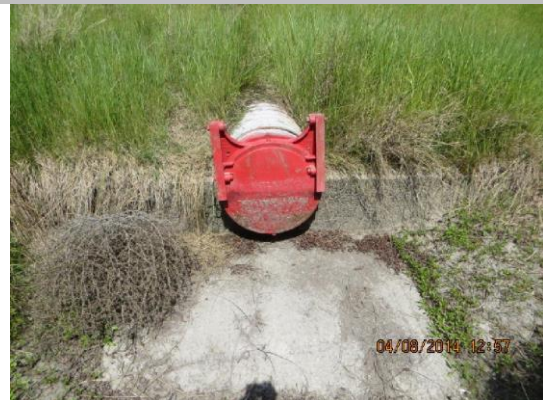
Photo 2 of 3 : UCIP_SP_2020_39244_60847.jpg

Pipe, Headwall, and flapgate at WS toe.

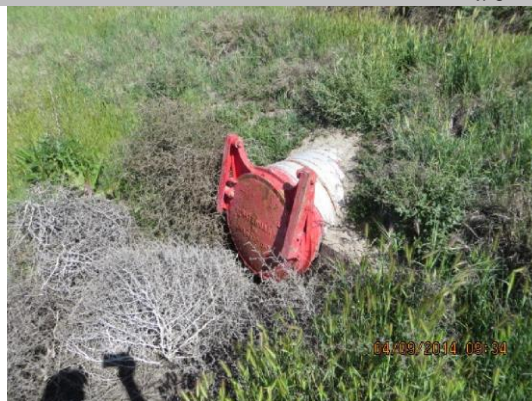
Photo 2 of 3 : UCIP_SP_2020_39245_60848.jpg

Concrete headwall, pipe, and flapgate at WS toe.

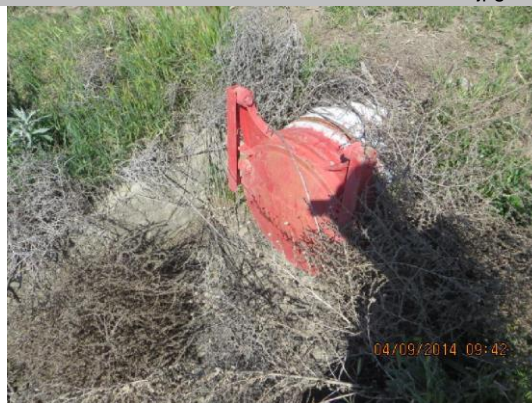
Photo 2 of 3 : UCIP_SP_2020_39246_60855.jpg

Pipe, Flapgate, and headwall on WS toe.

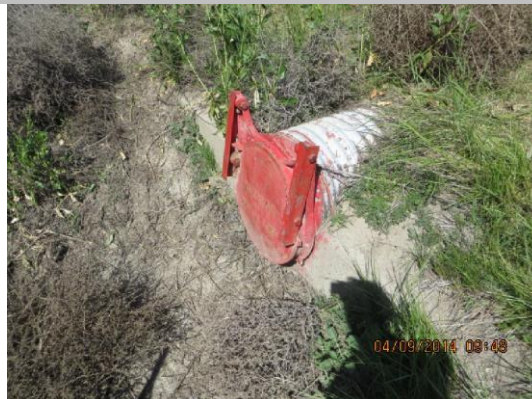
Photo 2 of 3 : UCIP_SP_2020_39247_60860.jpg

Pipe, flapgate, and headwall on WS toe.

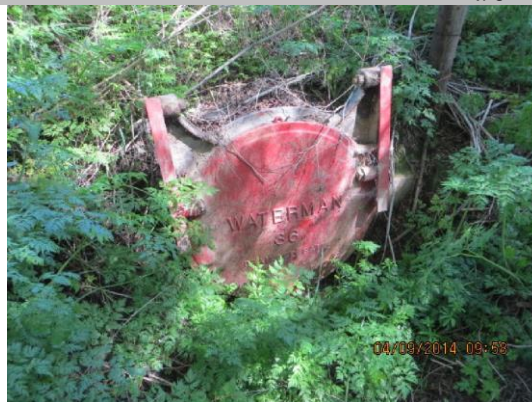
Photo 2 of 3 : UCIP_SP_2020_39249_60869.jpg

Pipe and flapgate visible on WS toe.

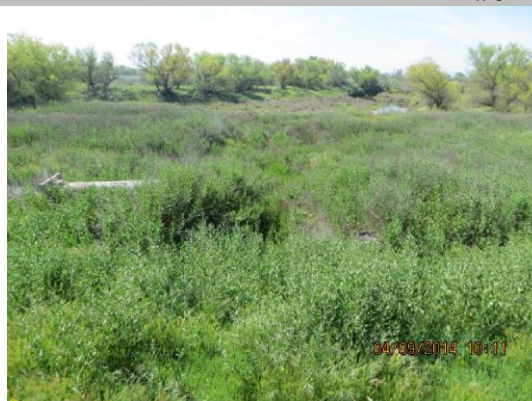
Photo 1 of 3 : UCIP_SP_2020_39251_60875.jpg

DS_ID:19627
 FS_ID:39251
 EP_NO: N/A
 Repair Type: Non-Urgent
 Crossing Status: Found
 UCIP Comments: 04/09/2014 Dense vegetation limits the inspector's visibility to identify signs of pipe failure (leaks) along the slope. Recommend removing vegetation along pipe alignment to conduct proper inspection of structure. (DWR UCIP - W. Wylie)
 FIELD_STRUCT_DESC: 24-inch corrugated metal gravity drainage pipe through the levee, 8.6 feet below the crown. Concrete drop inlet at the landside (LS) toe. Flap gate on the waterside (WS) end. Brass cap No. 80 bench mark (BM) on the headwall on the LS. [Additional Reference(s): DWR Levee Log, 2002. USACE San Joaquin O&M Manual 601.1, 1967, (HLM 9.37)].
 FS Date: 4/9/2014

Pipe and flapgate on WS toe.

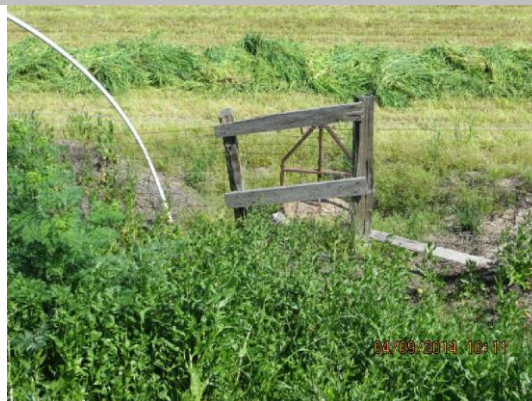
Photo 3 of 3 : UCIP_SP_2020_39251_60874.jpg

Concrete drop-inlet installed on pipe at LS toe.

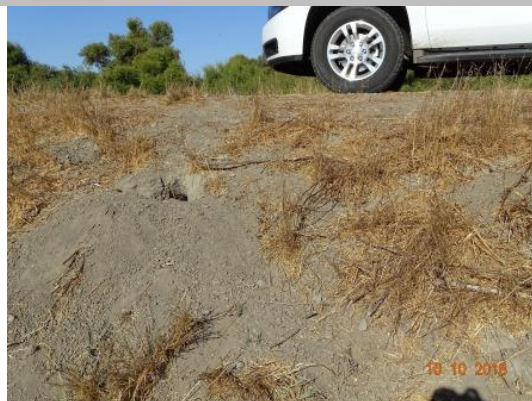
Photo 1 of 1 : SP_2020_NA0010_118_120_20200225_00033.jpg

LM Start	9.94	Rating **	U	Issue No.	120
LM End	9.97	Issue Type +	Ma	Location *	LS
Category	Earthen Levee			GPS Latitude/Longitude	
				Start	End
Item	Animal Control			37.290994 °	37.290673 °
				-120.839758 °	-120.839988 °
DWR ID	DWR_NA0010_01_f_2018_120				
Comment Code					
A3 : No rodents visible, but rodent burrows visible; need to backfill and compact or grout burrows.					
Inspector Comment					
Rodent burrows observed in this section with large amount of material displaced.

View of rodent burrow in the landside slope. (Fall 2018)

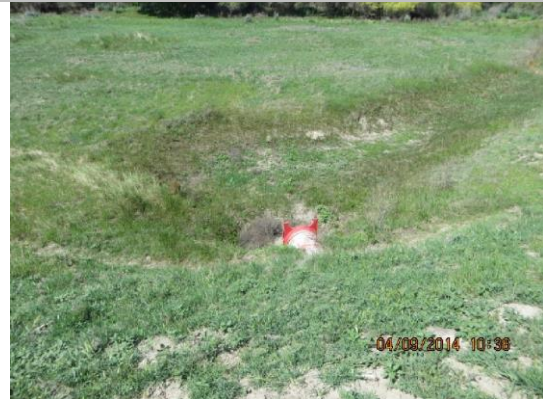
Photo 1 of 3 : UCIP_SP_2020_39253_60884.jpg

Comment Code						
Inspector Comment						
DS_ID:19629 FS_ID:39253 EP_NO: N/A Repair Type: Non-Urgent Crossing Status: Found UCIP Comments: 04/09/2014 Dense vegetation blocks waterward and landward toes Recommend removing vegetation from both toes. Also sediment buildup in pipe visible from landward side. (DWR UCIP - W. Wylie) FIELD_STRUCT_DESC: 24-inch corrugated metal gravity drainage pipe through the levee, 9 feet below the crown. Flap gate on the waterside (WS) end. Brass cap No. 69 bench mark (BM) on the headwall on the landside (LS). [Additional Reference(s): DWR Levee Log, 2002. USACE San Joaquin O&M Manual 601.1, 1967, (HLM 10.23)]. FS Date: 4/9/2014

Pipe, headwall, and flapgate on WS toe.

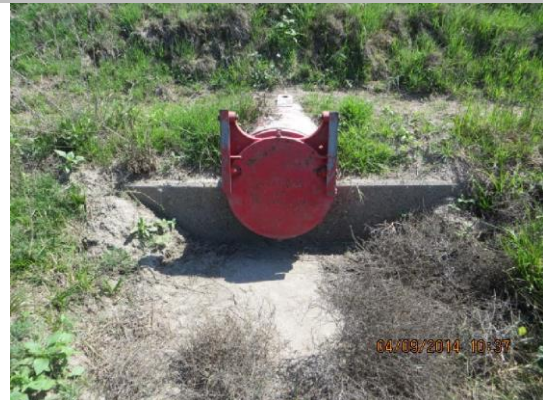
Photo 2 of 3 : UCIP_SP_2020_39253_60886.jpg

Pipe, headwall, and flapgate at WS toe.

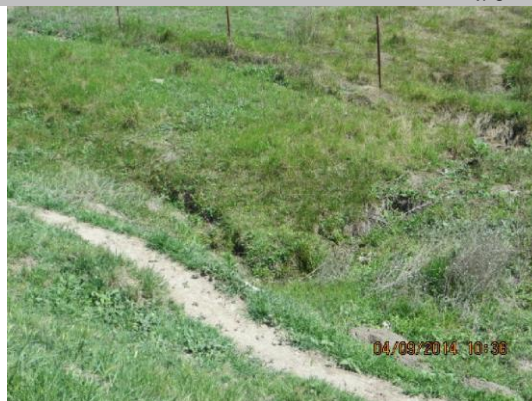
Photo 3 of 3 : UCIP_SP_2020_39253_60885.jpg

Pipe and headwall at LS toe.

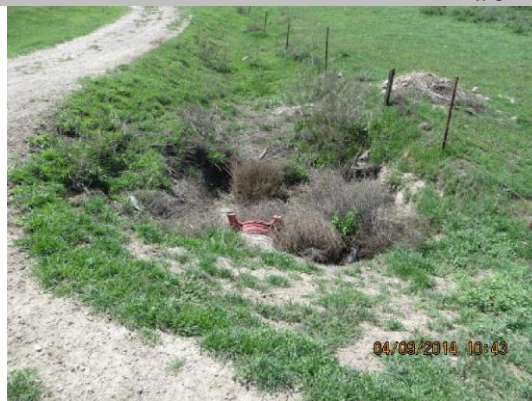
Photo 1 of 3 : UCIP_SP_2020_33687_60890.jpg

DS_ID:19630
 FS_ID:33687
 EP_NO: N/A
 Repair Type: No Action Needed
 Crossing Status: Found
 UCIP Comments:
 FIELD_STRUCT_DESC: 24-inch corrugated metal gravity drainage pipe through the levee, 7 feet below the crown. Flap gate on the waterside (WS) end. Brass cap No. 68 bench mark (BM) on the headwall on the landside (LS). [Additional Reference(s): DWR Levee Log, 2002. USACE San Joaquin O&M Manual 601.1, 1967, (HLM 10.72)].
 FS Date: 4/9/2014

Pipe and flapgate on WS toe.

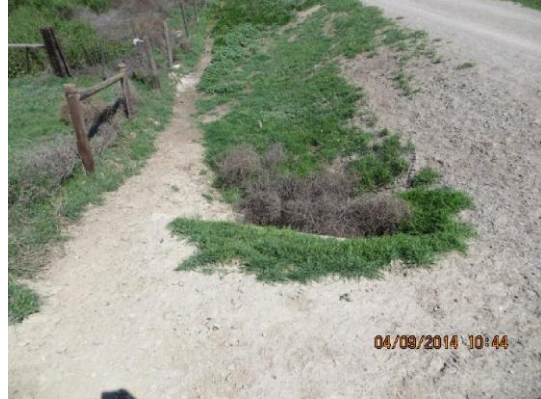
Photo 2 of 3 : UCIP_SP_2020_33687_60889.jpg

Pipe and headwall on LS toe.

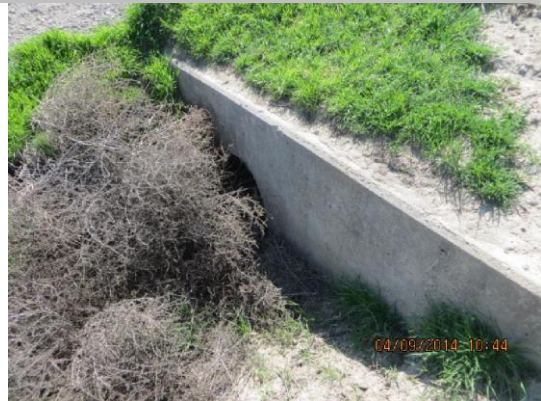
Photo 3 of 3 : UCIP_SP_2020_33687_60888.jpg

Pipe and headwall on LS toe.

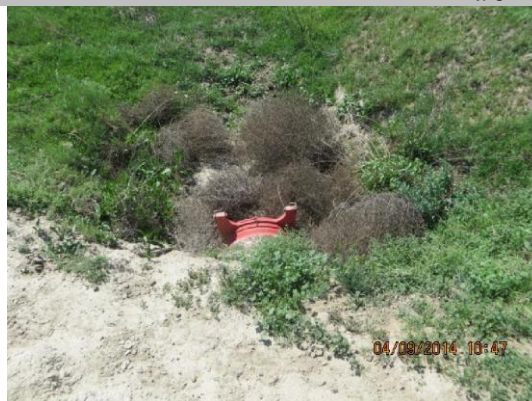
Photo 1 of 3 : UCIP_SP_2020_39254_60894.jpg

LM Start	10.69	Rating **	A/W	Issue No.	1229
LM End	10.69	Issue Type +	Ma	Location *	
Category	Supplemental			GPS Latitude/Longitude	
				Start	End
Item	DWR UCIP LMA Responsibility			37.283710 °	37.283710 °
				-120.833329 °	-120.833329 °
DWR ID	19631				
Comment Code					
Inspector Comment					
DS_ID:19631 FS_ID:39254 EP_NO: N/A Repair Type: No Action Needed Crossing Status: Found UCIP Comments: FIELD_STRUCT_DESC: 24-inch corrugated metal gravity drainage pipe through the levee, 7 feet below the crown. Flap gate on the waterside (WS) end. Brass cap No. 67 bench mark (BM) on the headwall on the landside (LS). [Additional Reference(s): DWR Levee Log, 2002. USACE San Joaquin O&M Manual 601.1, 1967, (HLM 10.72)]. FS Date: 4/9/2014

Headwall, pipe, and flapgate on WS toe.

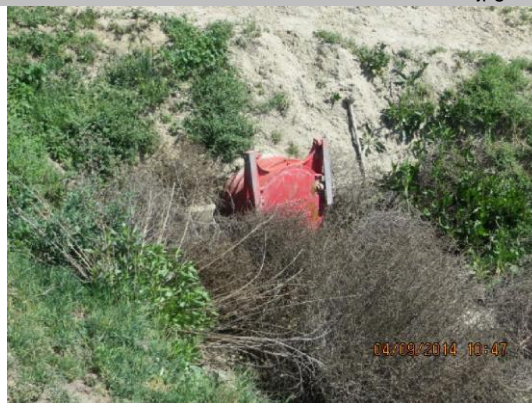
Photo 2 of 3 : UCIP_SP_2020_39254_60893.jpg

Headwall, pipe, and flapgate on WS toe.

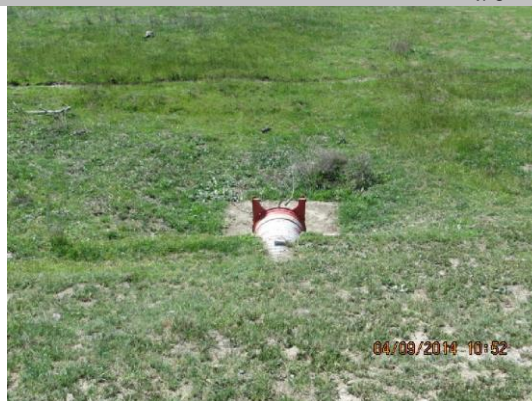
Photo 1 of 3 : UCIP_SP_2020_39255_60897.jpg

Comment Code						
Inspector Comment						
DS_ID:19632						
FS_ID:39255						
EP_NO: N/A						
Repair Type: Non-Urgent						
Crossing Status: Found						
UCIP Comments: 04/09/2014 Dense vegetation blocks landward headwall. Recommend removing excess vegetation on landward toe. (DWR UCIP - W. Wylie)						
FIELD_STRUCT_DESC: 24-inch corrugated metal gravity drainage pipe through the levee, 6 feet below the crown. Flap gate on the waterside (WS) end. Brass cap No. 66 bench mark (BM) on the headwall on the landside (LS). [Additional Reference(s): DWR Levee Log, 2002. USACE San Joaquin O&M Manual 601.1, 1967, (HLM 11.00)].						
FS Date: 4/9/2014

Pipe, headwall, and flapgate on WS toe.

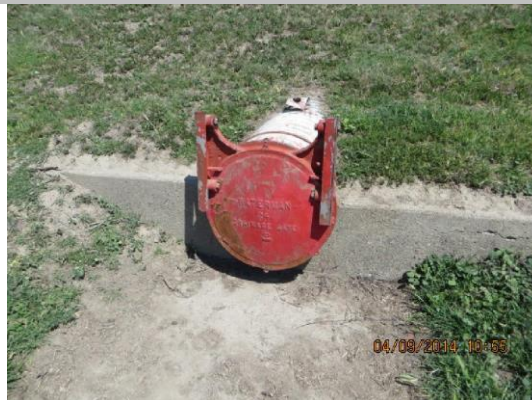
Photo 2 of 3 : UCIP_SP_2020_39255_60899.jpg

Pipe, headwall, and flapgate on WS toe.

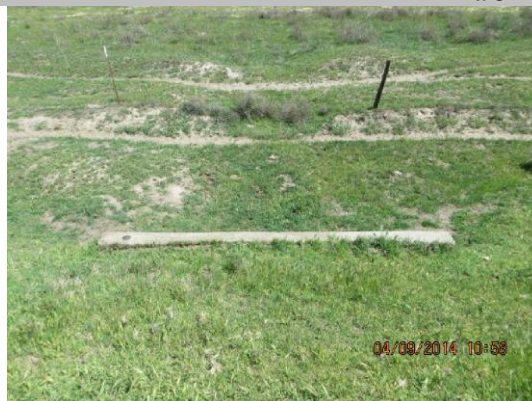
Photo 2 of 3 : UCIP_SP_2020_33690_60902.jpg

Pipe and headwall at LS toe.

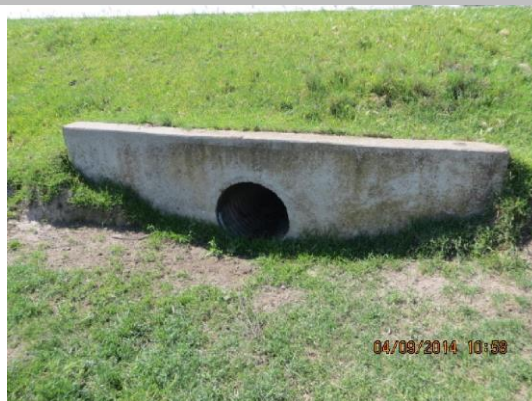
Photo 3 of 3 : UCIP_SP_2020_33690_60901.jpg

Pipe and headwall at LS toe.

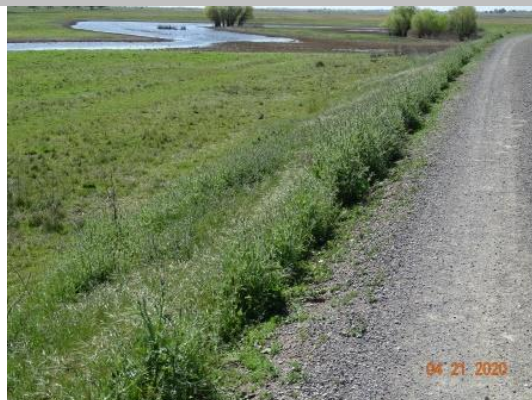
Photo 1 of 1 : SP_2020_NA0010_118_152_20200506_00300.jpg

LM Start	11.44	Rating **	U	Issue No.	152
LM End	11.57	Issue Type +	Ma	Location *	LS
Category	Earthen Levee			GPS Latitude/Longitude	
				Start	End
Item	Vegetation			37.274522 °	37.272619 °
				-120.825729 °	-120.825741 °
DWR ID	DWR_NA0010_01_s_2020_152				
Comment Code					
V1 : Control annual grass and weeds on the levee slopes and easements.					
Inspector Comment

View of landside slope looking upstream. (Spring 2020)
